Tillamook County, Oregon Shilo Levee Rehabilitation

TO: Chris Laity, PE – Tillamook County Public Works
FROM: Jason Kelly, PE – DOWL
Ben Wewerka, PE – DOWL
Brian Meunier, PE, CFM – DOWL
DATE: August 26, 2022
SUBJECT: Shilo Training Structure
Site Assessment

Bank Protection Project Inspection Report

Name of Project: Wilson River (Revetment)

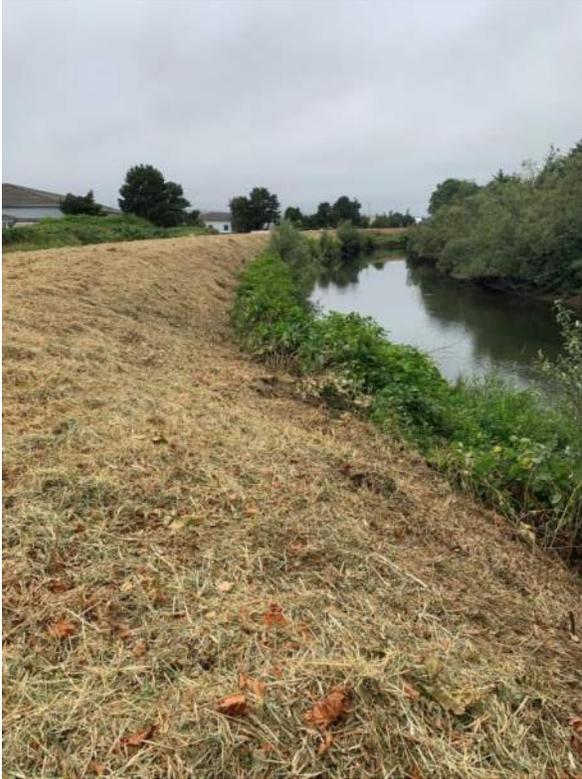
LOOKING DOWNSTREAM FROM STA. 1+50 APPROX.

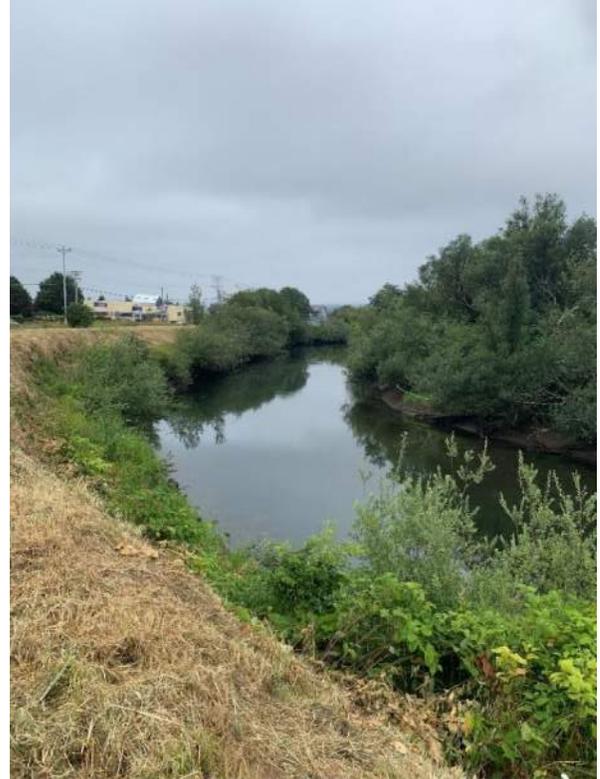
LOOKING DOWNSTREAM FROM STA. 6+50 APPROX.

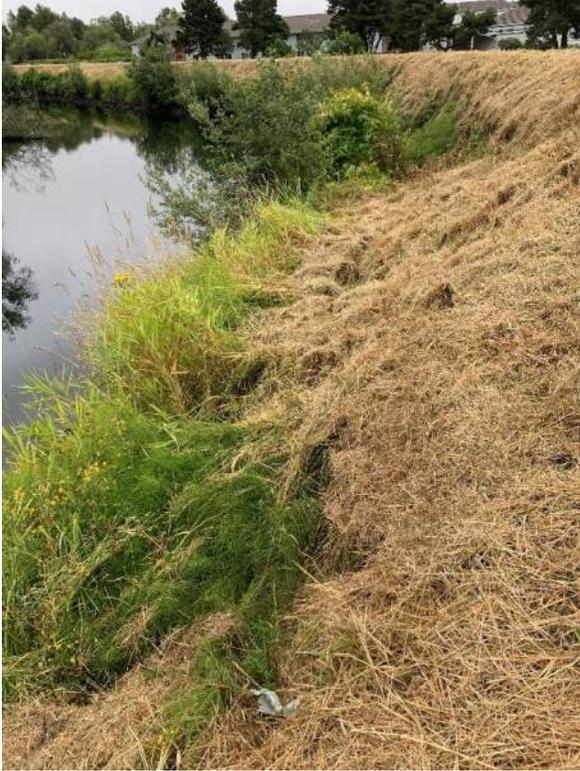
VERTICAL SLOPE BETWEEN STA. 7+00 AND 8+50 APPROX.

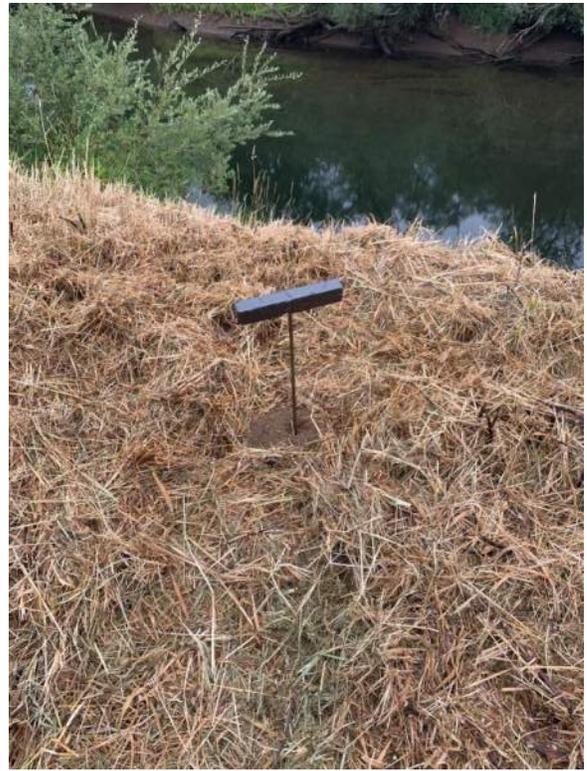
RODENT HOLE WITH PROBE PENETRATION 2.5-3 FEET

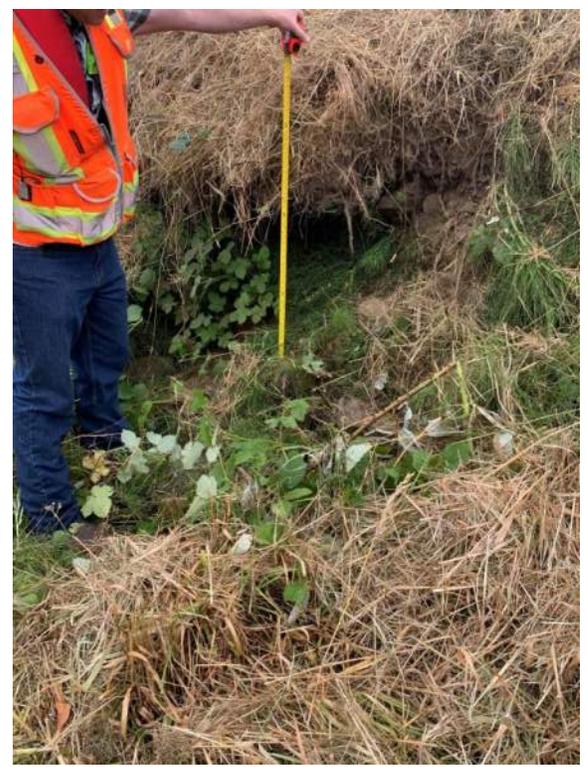
UNDERCUT SLOPE STA. 8+40

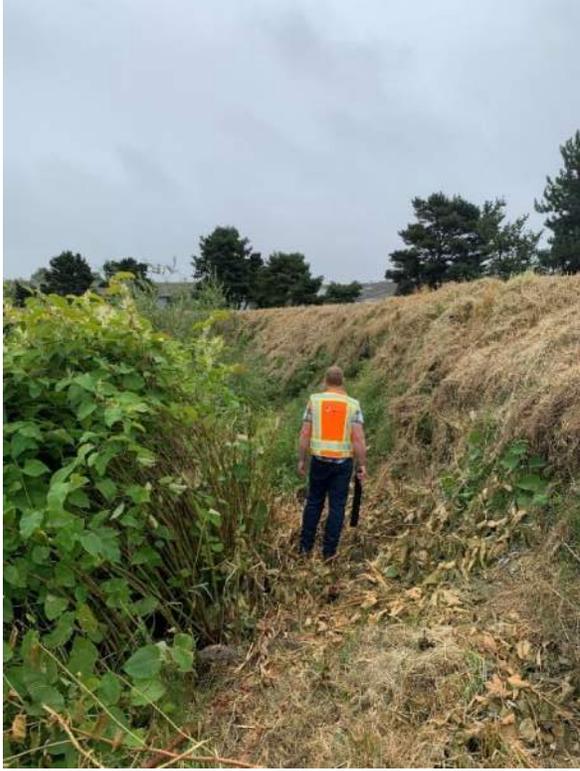
VERTICAL SLOPE STA. 8+25

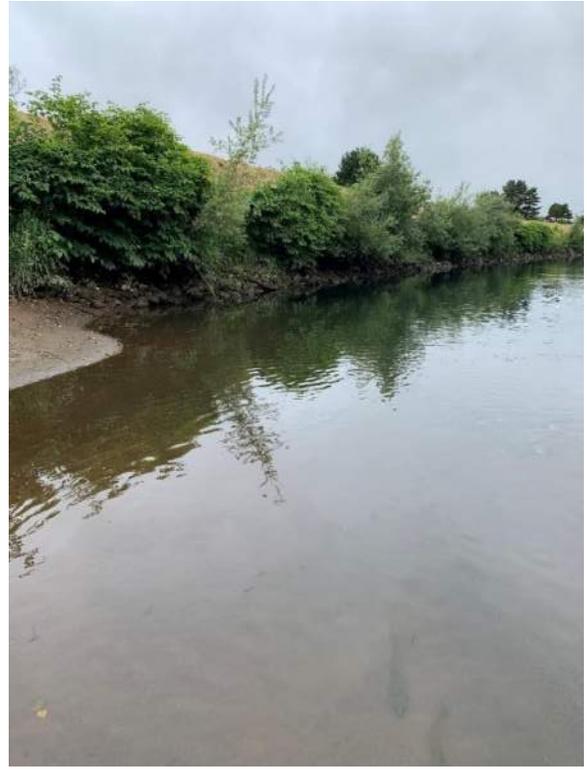
Evidence of prior erosion repairs was also found near the east end in the forms of sandbags along the ordinary high-water mark. The sandbags were placed immediately upstream of the visible riprap bank protection.

SANDBAGS AT BEGINNING OF THE TRAINING STRUCTURE STA. 1+50

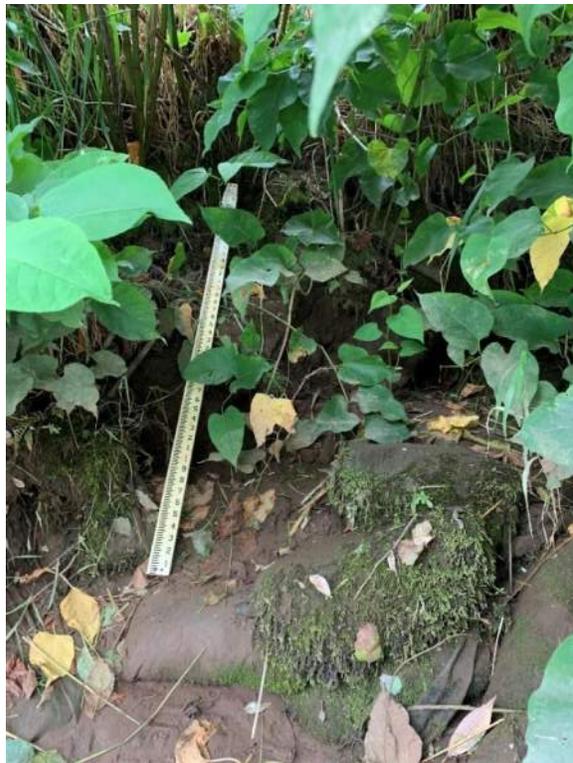
BANK FAILURE ABOVE SANDBAGS STA. 1+50

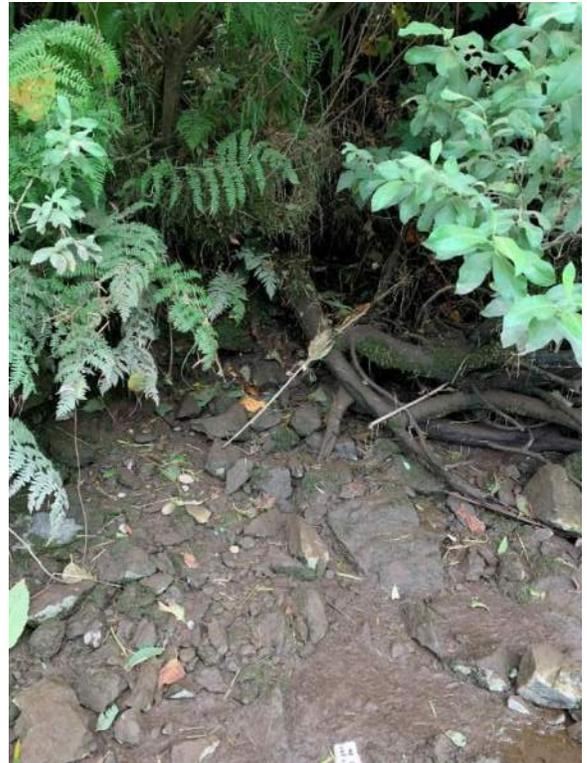
RIPRAP AND BANK FAILURE STA. 2+00 APPROX.

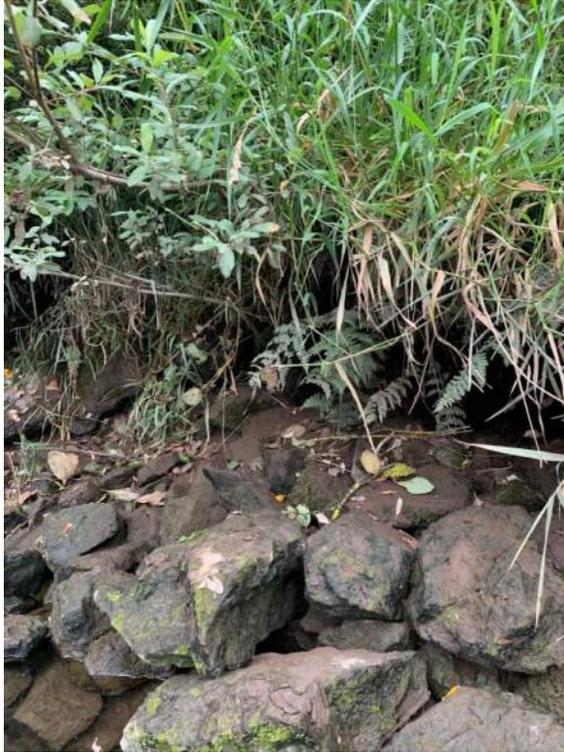
UNDER CUT BANK STA 6+00

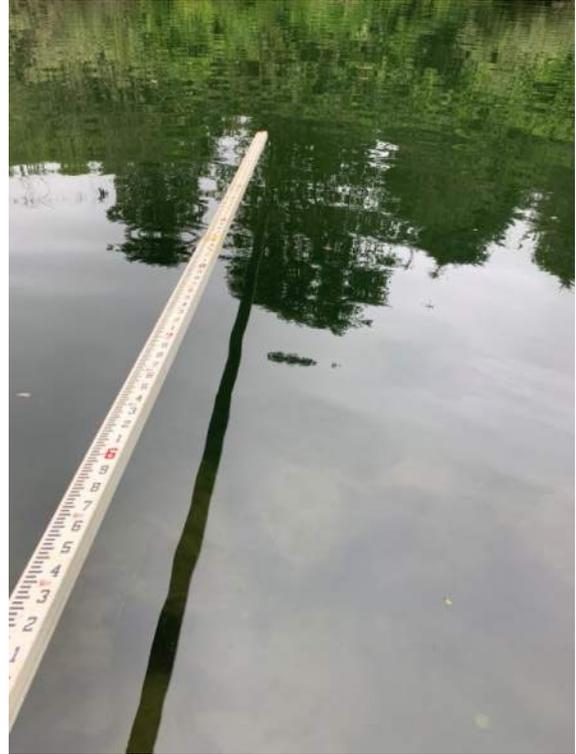
RIPRAP EXTEND 12 FEET INTO RIVER FROM
ORDINARY HIGH WATER

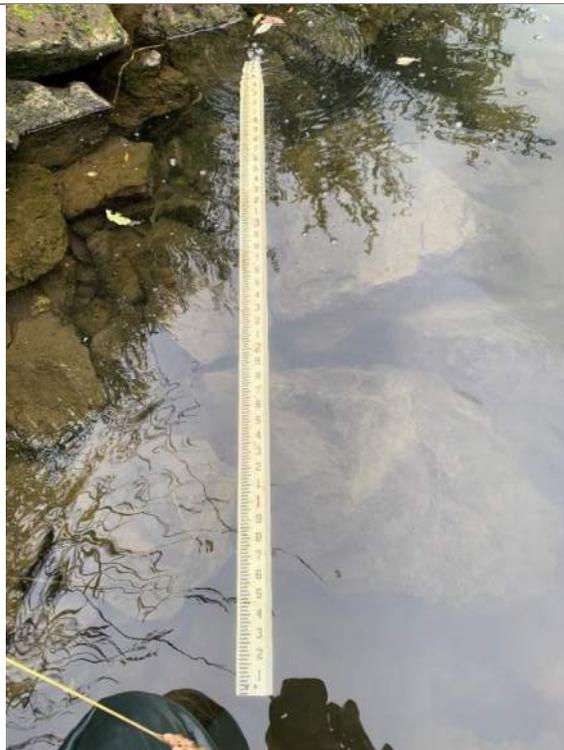
RIPRAP SIZES NEAR TOE OF SLOPE

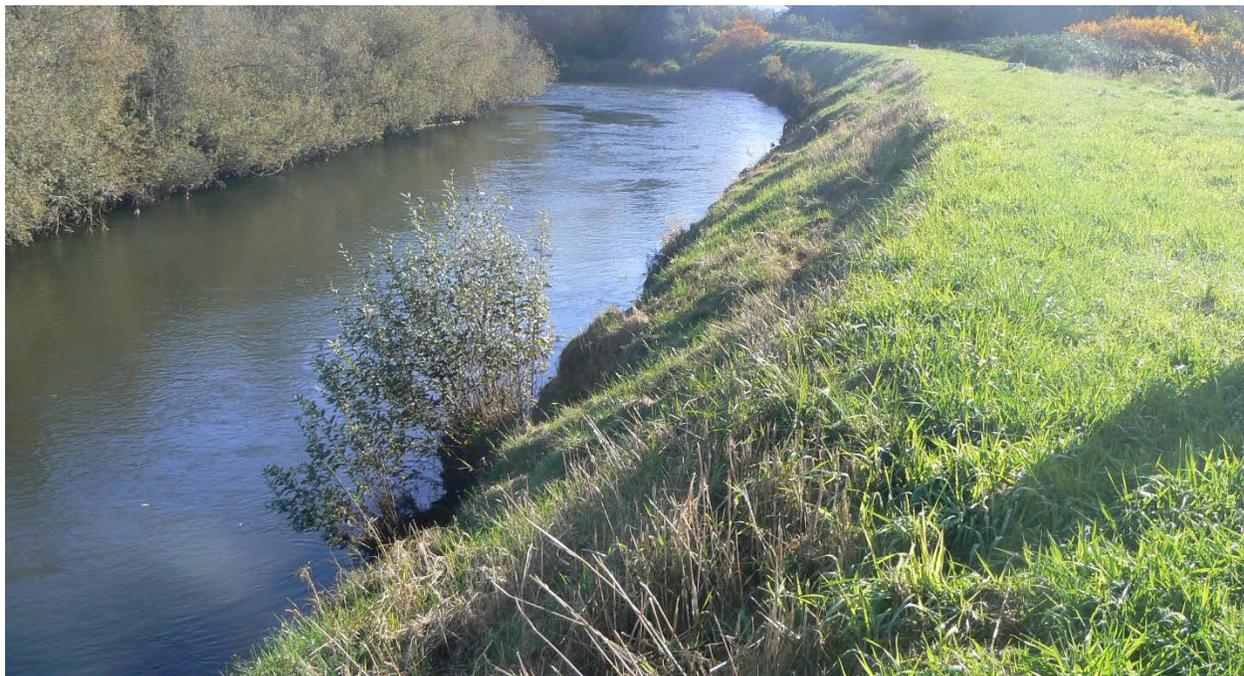
Middle and upper portion of revetment looking upstream. Note small willow needing to be cut.

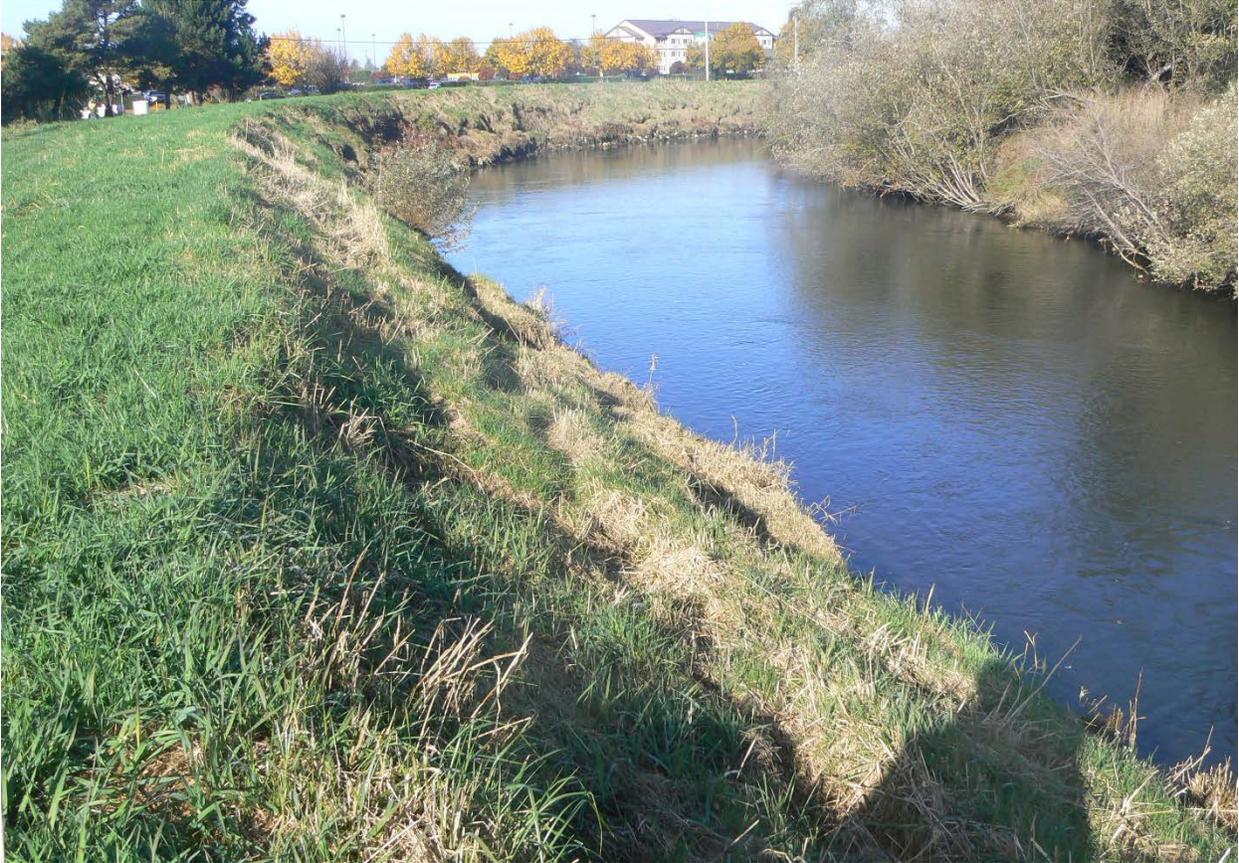
View D/S of middle and lower portion of revetment. Older cracks in overlying silt running parallel to the river are visible on the slope.

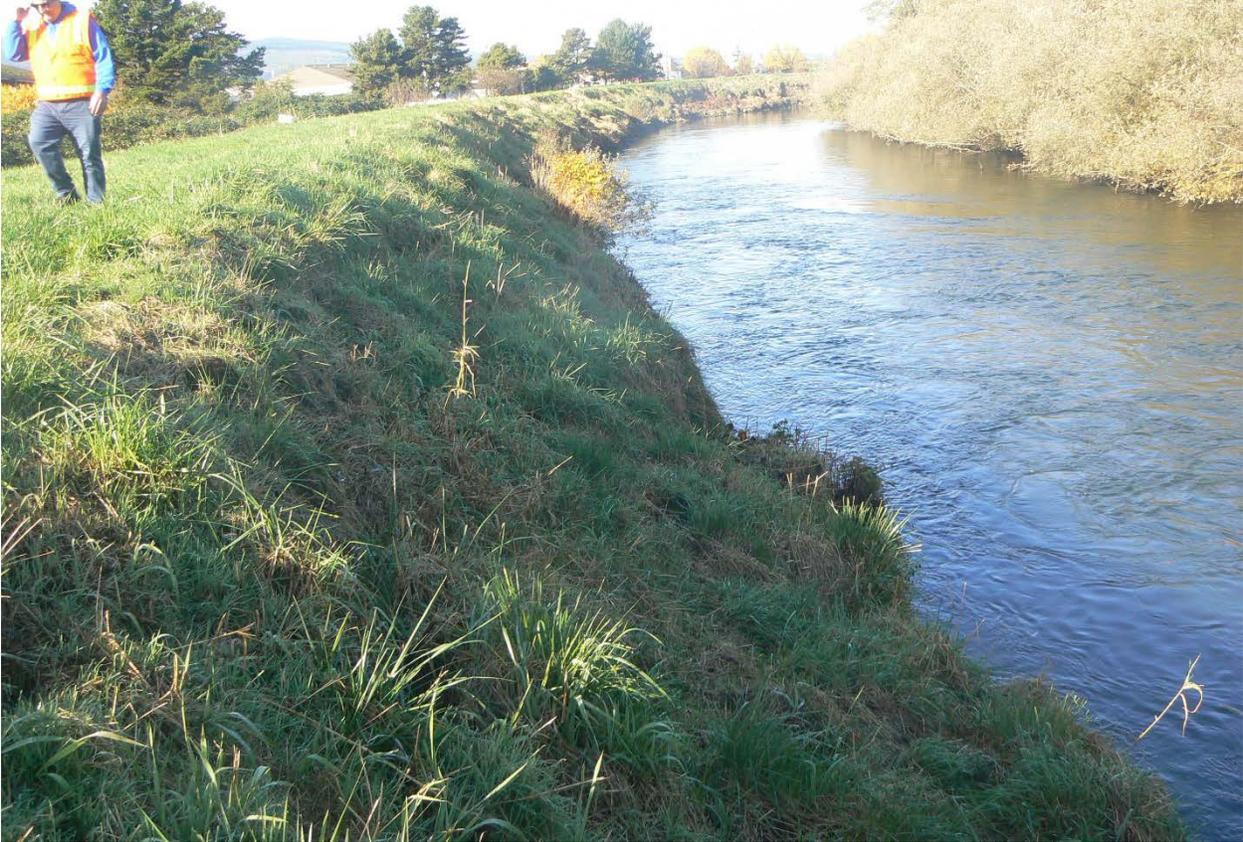
View downstream from upstream end of revetment. Riprap not visible from top of slope.

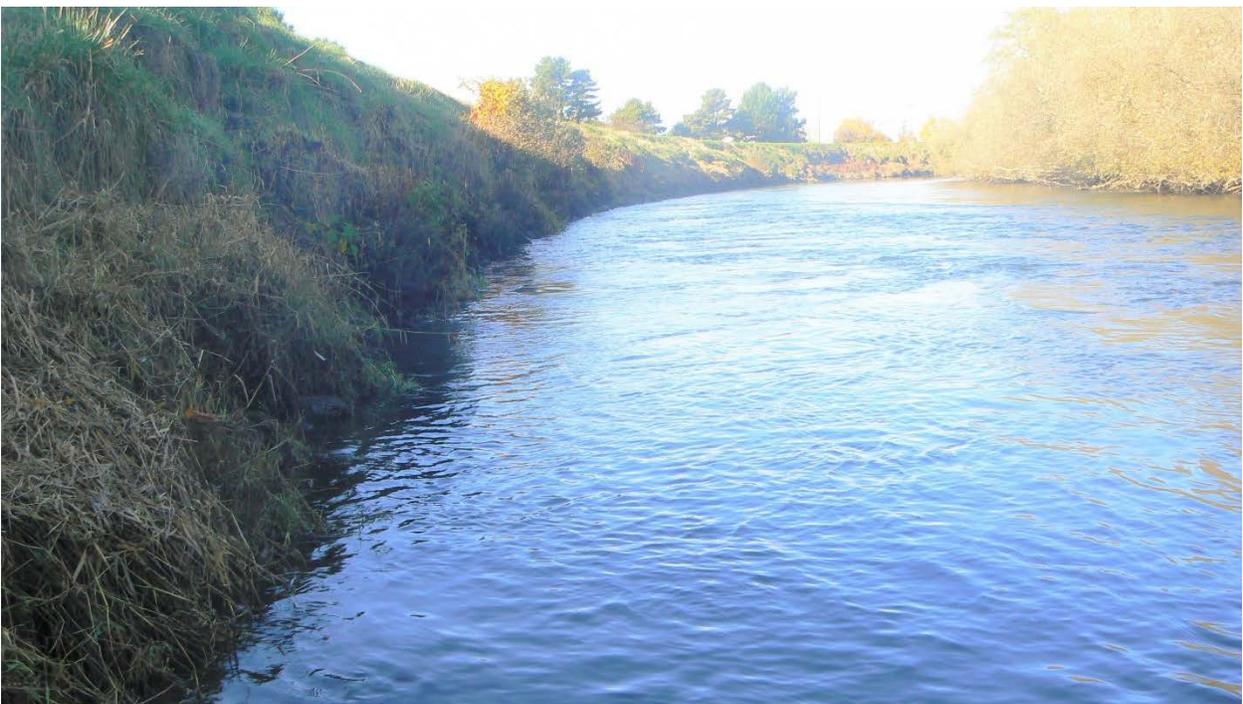
View downstream of riprap exposed at waterline taken from U/S end of revetment. Note the thick layer of silt creating an oversteepened slope that is overlying the 1V:2H riprap slope.

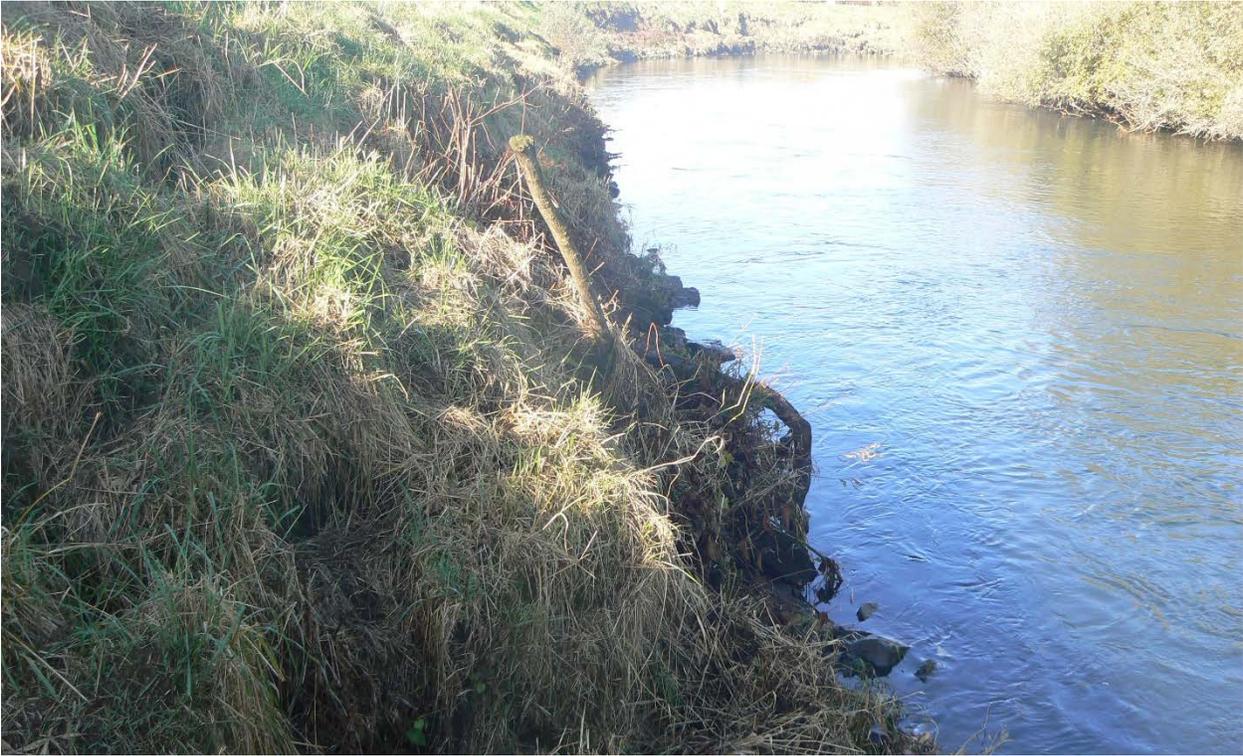
Woody debris caught between slumped blocks of silt on lower slope of revetment. Should be removed to prevent additional debris from getting caught and exacerbating erosion.

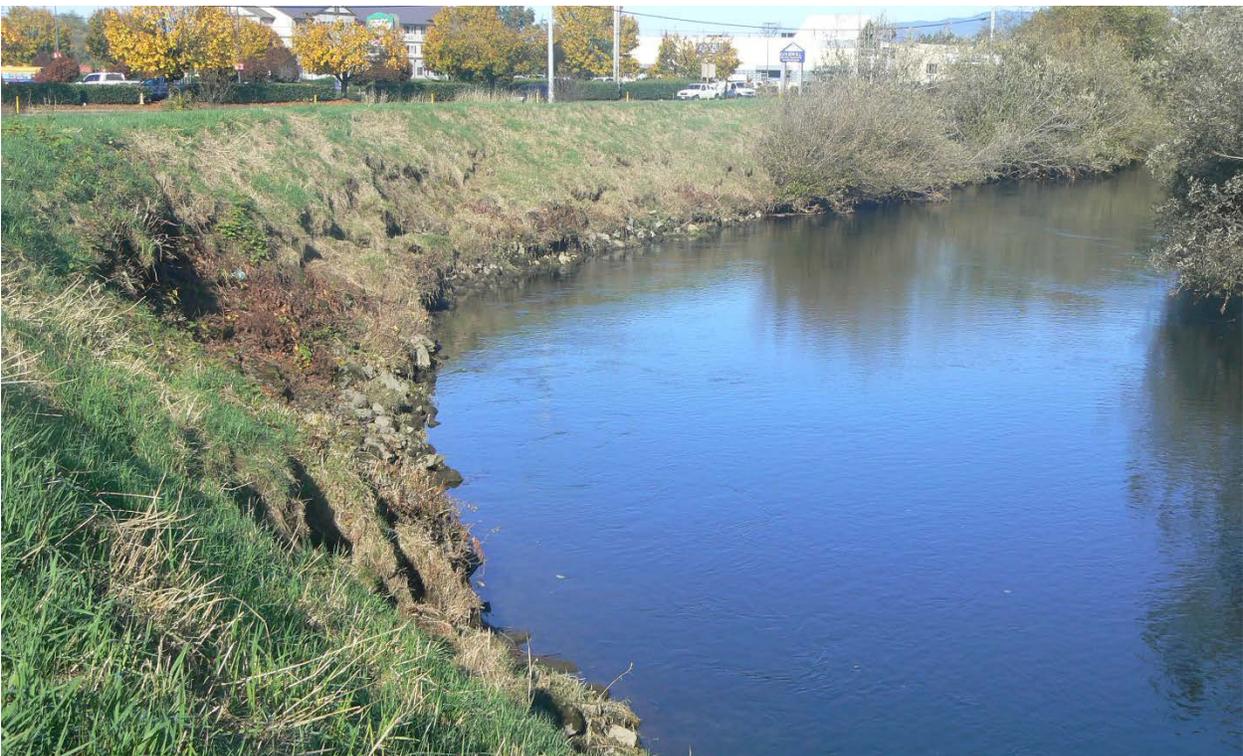
View D/S of overlying silt erosion on lower slope exposing riprap between Sta. 7+00 to 8+00.

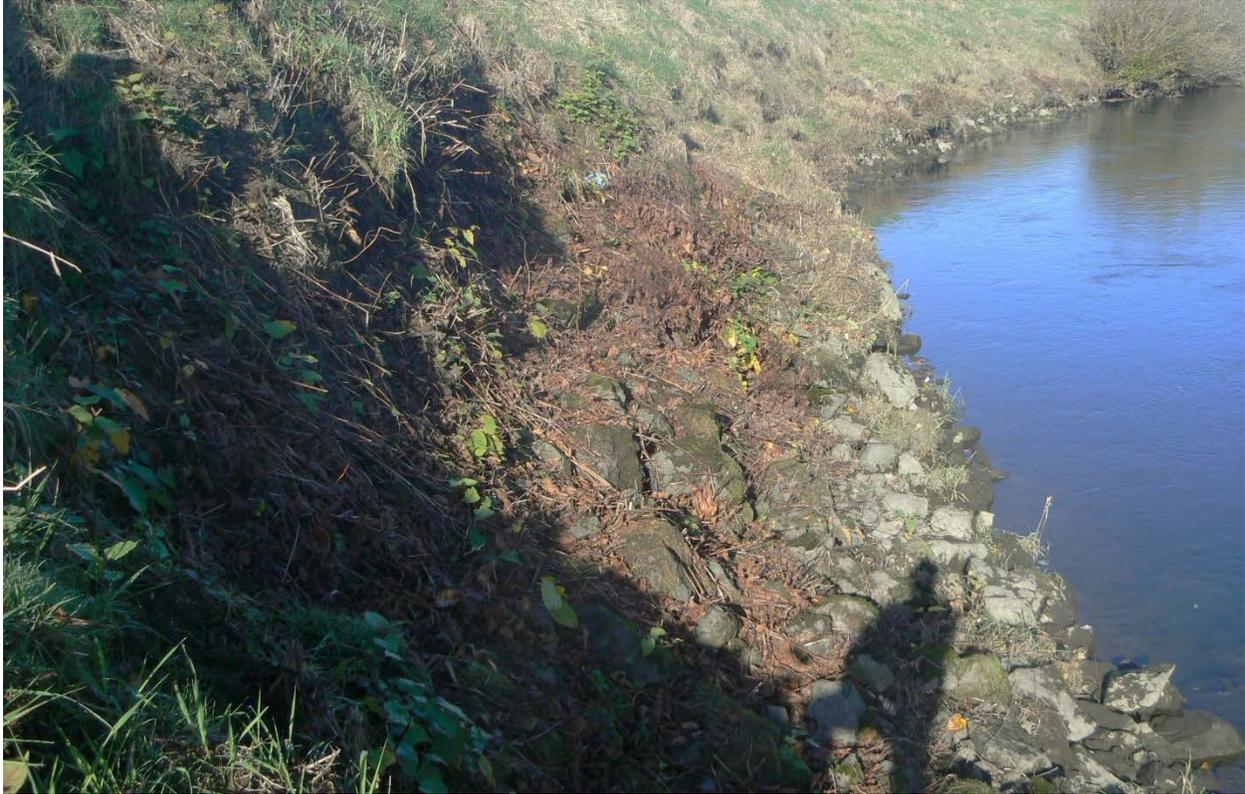
Close-up of area just before bend where river has eroded the overlying thick silt layer present on the 1V:2H riprap slope. Any lost riprap needs to be replaced to restore slope integrity.

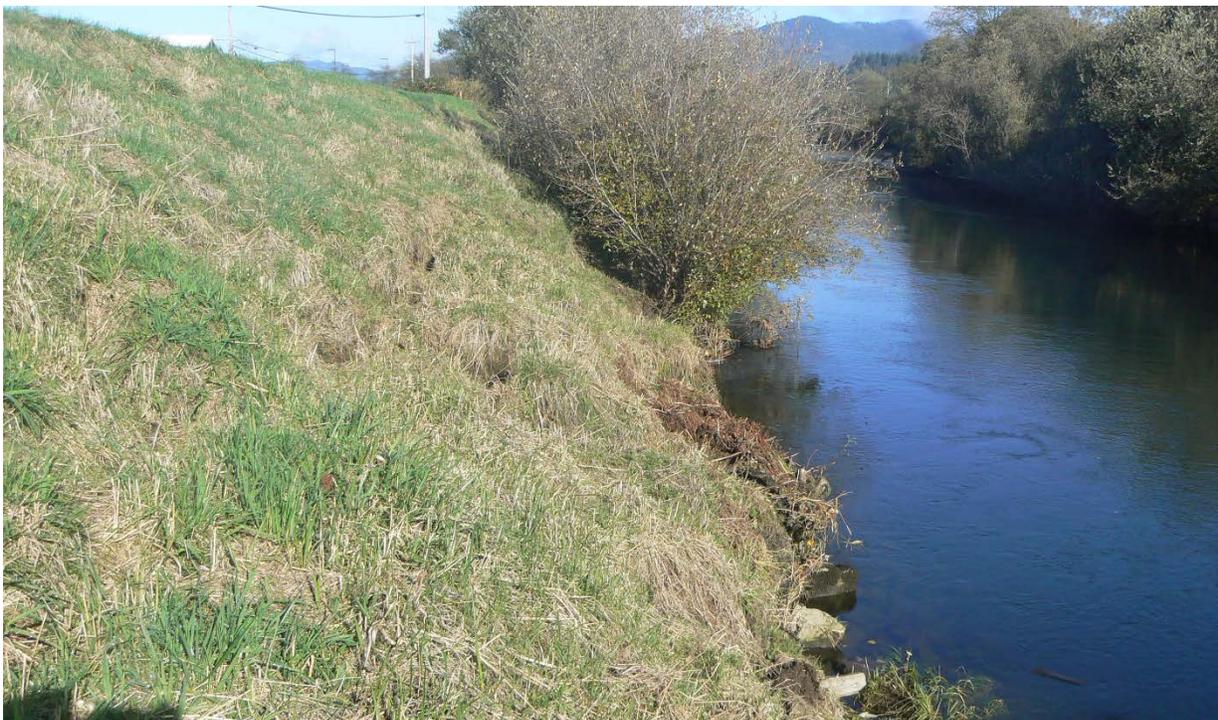
View downstream from near Sta. 8+00. Some riprap exposed at waterline. Trees need to be removed from slope or at least have back sides cut to reduce drag during high water events.

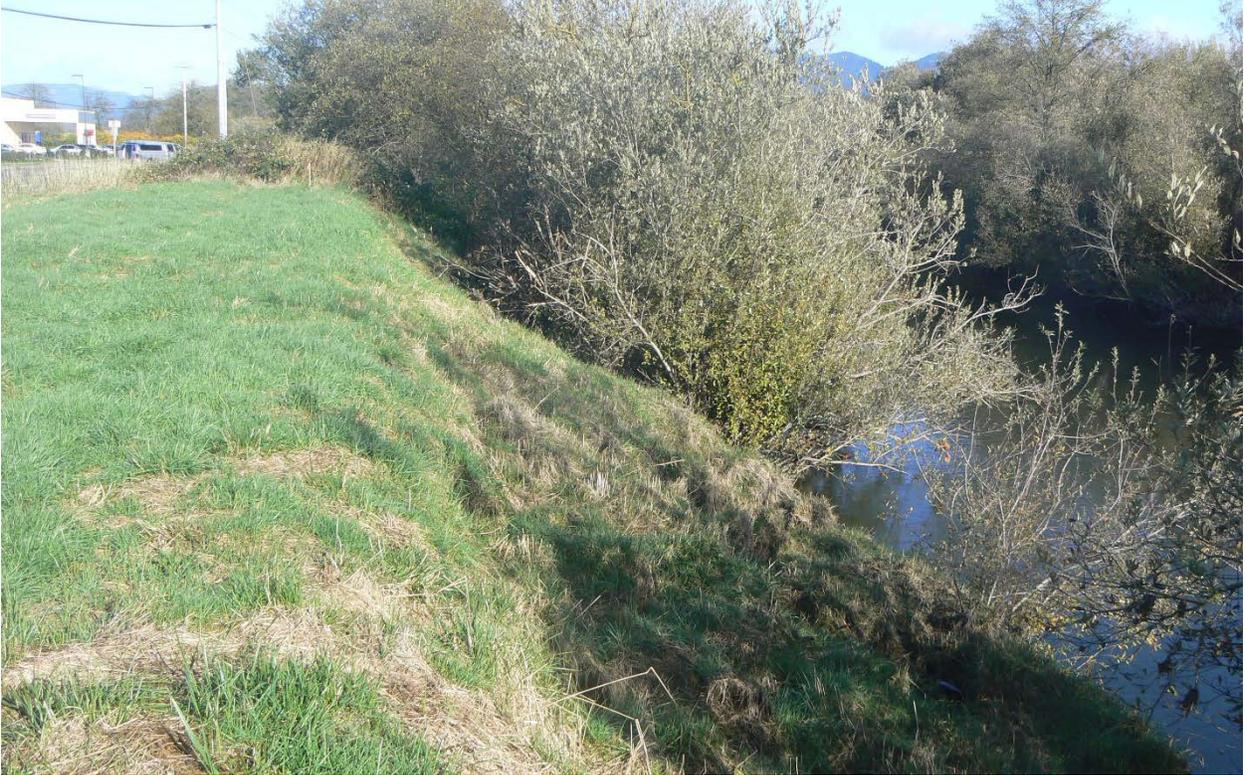
Areas of large willows growing through lower end of revetment slope. Numerous slumped silt areas present in this area. D/S end of project is located just beyond the blackberries on crest.

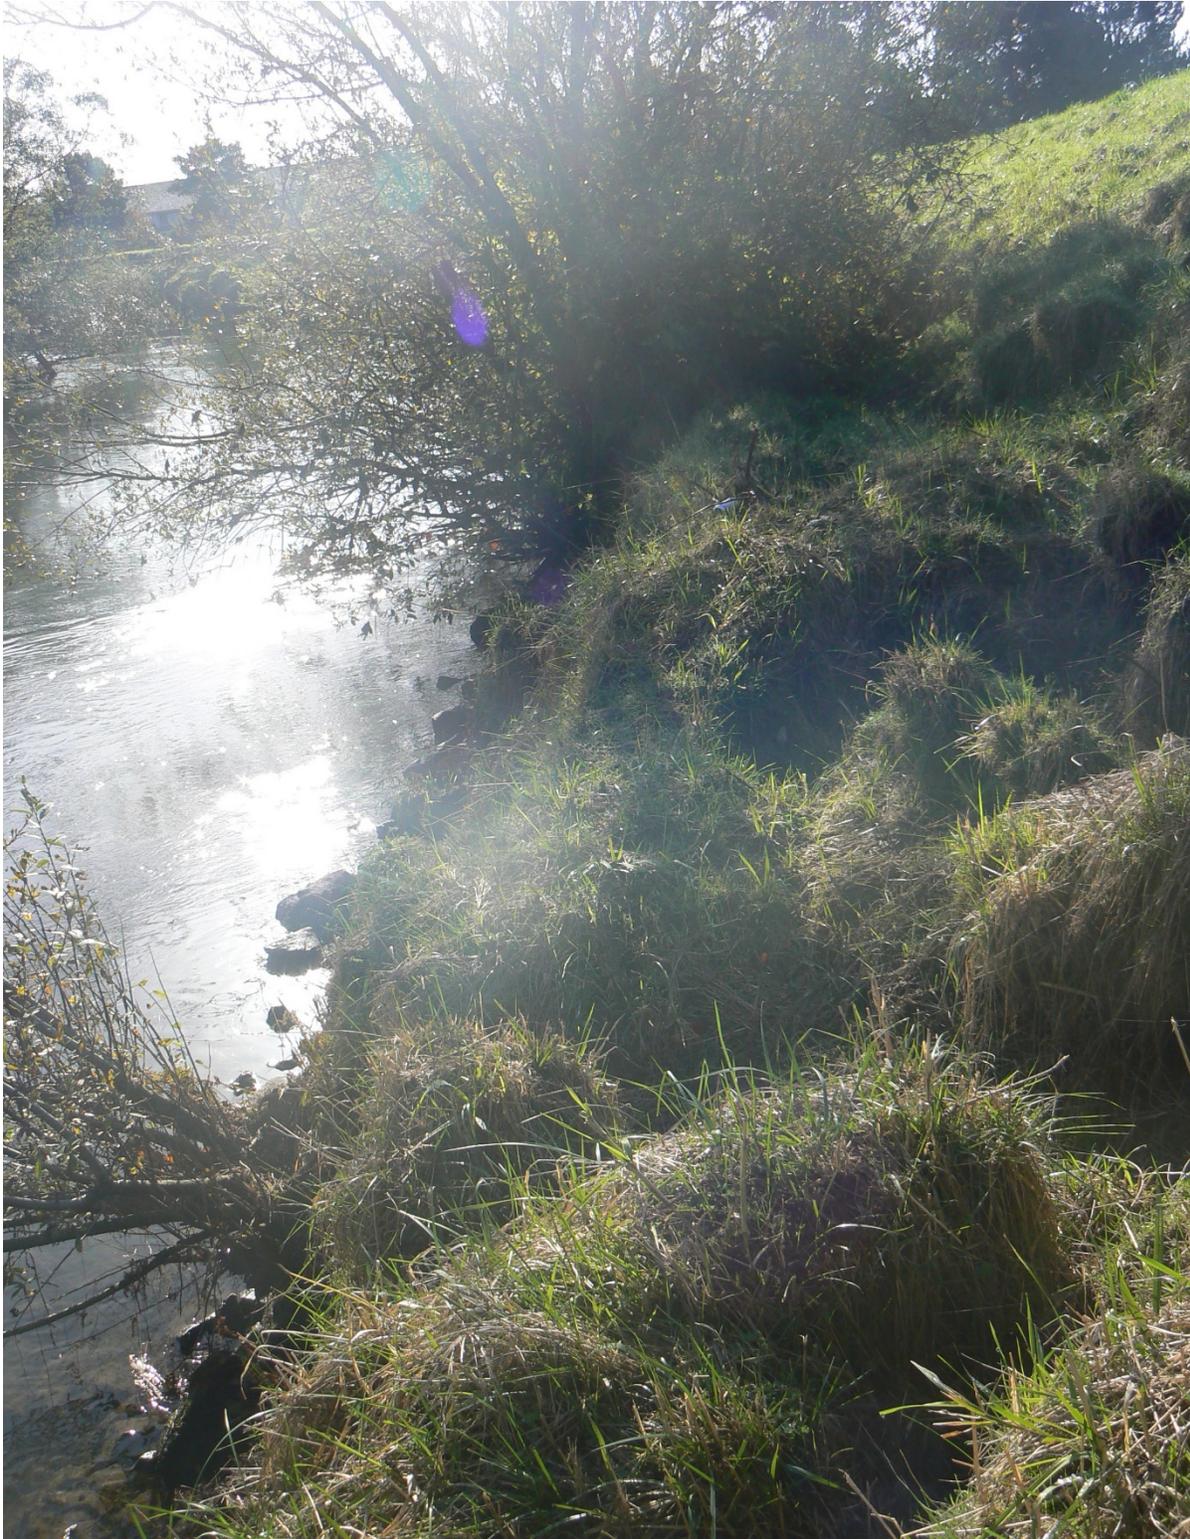
View upstream from near downstream end of project. Numerous slumped blocks of silt overlying the riprapped slope and abundant willows growing through the revetment requiring removal or trimming of back side.
