Neskowin Coastal Hazard Area Permit #851-21-000283-PLNG: Capri & McMillan

NOTICE OF ADMINISTRATIVE REVIEW Date of Notice: October 22, 2021

TAX LOT #2000, MAP 5S-11W-36BC

Geologic Hazards and Geotechnical Investigation Tax Lot 2000, Map 5S-11W-36BC Neskowin, Tillamook County, Oregon

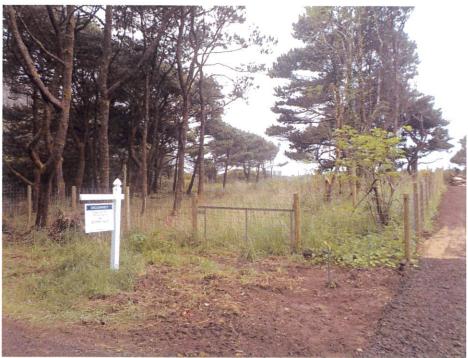
Photo 1 – Westerly view of the site from near the northeast property corner.

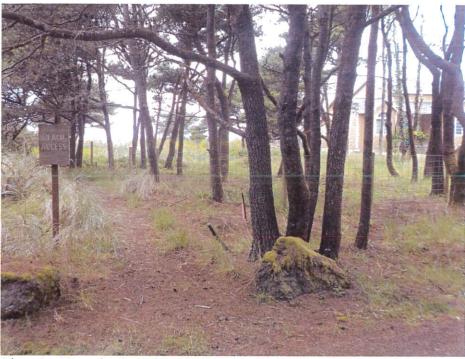
Photo 2 – Westerly view of the site from near the southeast property corner. Note the beach access path along the southern side of the site.

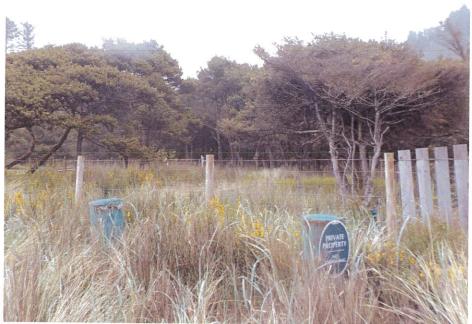
Photo 3 – Easterly view of the site from near the top of the riprap revetment.

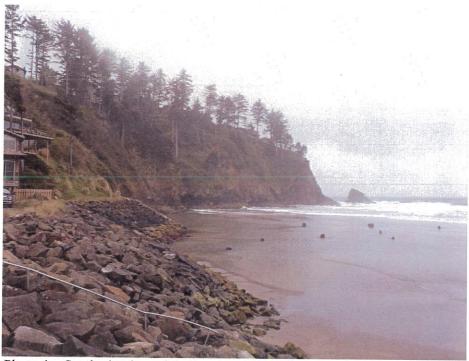
Photo 4 – Southerly view of the beach and bluff from the site. Note the stumps exposed on the beach.

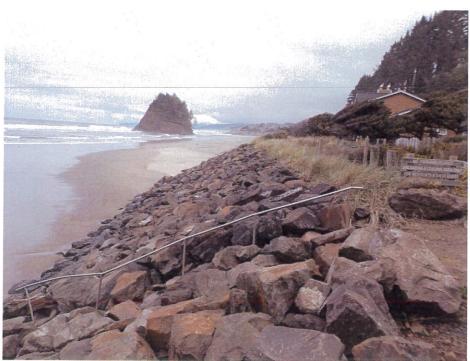
Photo 5 – Northerly view of the revetment, beach access stairs, and Neskowin Beach from just south of the site. Note the continuous riprap revetment along the dune slope.

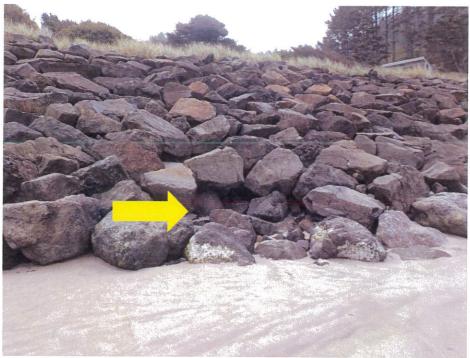
The site east of the riprap revetment is gently sloping down to the east at approximately 2 to 5 degrees at elevations between approximately 24 to 28 feet (NAVD 88) (Figures 3 and 4). The riprap revetment slopes down to the beach at approximately 30 degrees. We observed an area approximately 8 feet wide near the base of the exposed revetment where it appeared that armor stone had been plucked from the revetment in the past damaging the revetment (Appendix A).

The existing revetment located on the western portion of the subject site slopes down to the beach at approximately 30 degrees and consists of angular basalt boulders approximately 4 to 7 feet diameter on its lower portion and approximately 3 to 5 feet diameter on the upper portion (Figure 3; Appendix A). An approximately 8 feet wide area of the revetment appears to have been previously damaged and is missing armor stone near the base (Appendix A). Severe storms in the winter of 2007–2008 partly undermined the revetments in areas located along Neskowin Beach. The riprap revetment greatly reduces the potential for erosion when maintained and repaired as necessary.

Photo 6 – View of the riprap revetment at the base of the slope immediately west of the site. Yellow arrow indicates where larger armor stone has become displaced and the revetment is damaged.

The riprap revetment should be maintained and repaired as necessary to ensure its continued performance in reducing the potential for erosion at the site.

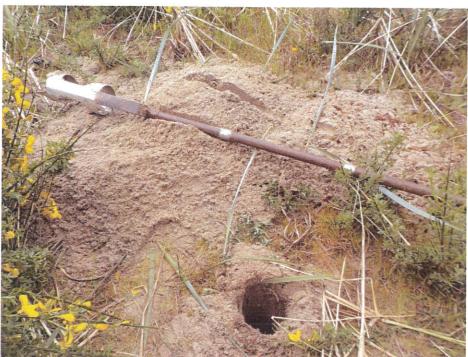
B-2	Depth (ft.) 0 - 3.0	<u>USCS</u> SP	<u>Description</u> Disturbed SAND; tan, wet, loose. Fine to medium- grained dune sand with grass roots in top 2 inches and occasional rock fragments up to 3-inch diameter.
	2.5 – 9.0	SP	SAND; tan, wet, medium dense to dense. Fine to medium-grained dune sand. Boring terminated in dense sand at approximately 9.0 feet. Free groundwater was not encountered.

Photo 7 – View of the dune sand encountered in boring B-2 to a depth of approximately 13 feet below the ground surface.
