Neskowin Coastal Hazard Area Permit #851-21-000283-PLNG: Capri & McMillan

NOTICE OF ADMINISTRATIVE REVIEW Date of Notice: October 22, 2021

TAX LOT #2000, MAP 5S-11W-36BC

Geologic Hazards and Geotechnical Investigation Tax Lot 2000, Map 5S-11W-36BC Neskowin, Tillamook County, Oregon

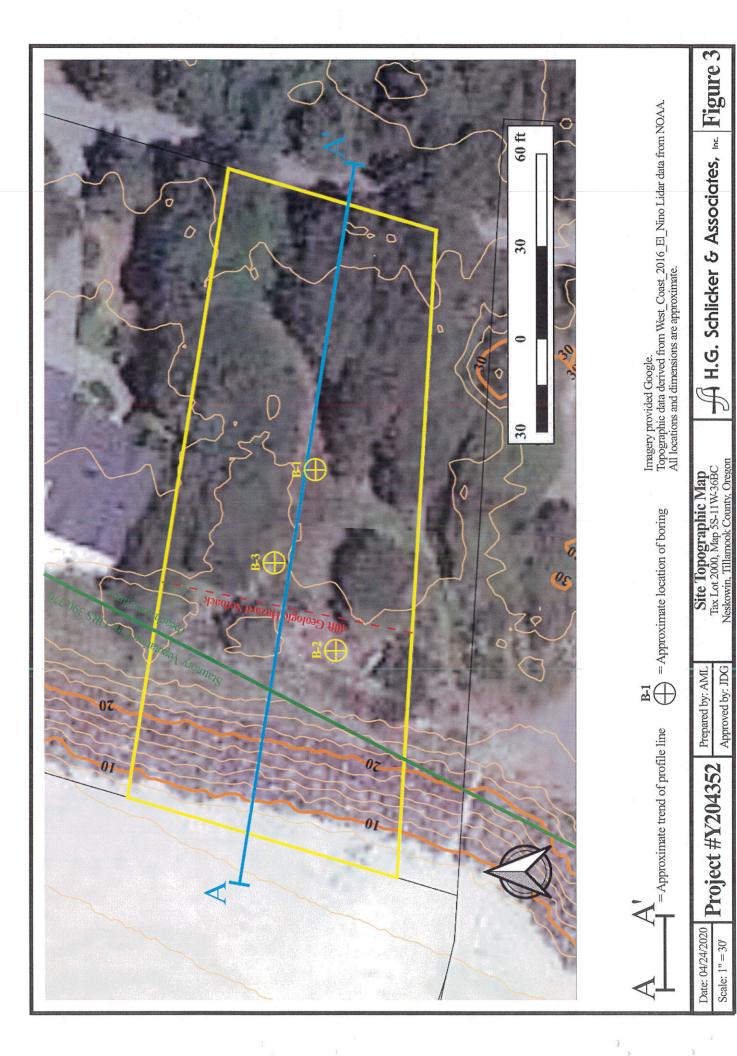
Figure 3

The site east of the riprap revetment is gently sloping down to the east at approximately 2 to 5 degrees at elevations between approximately 24 to 28 feet (NAVD 88) (Figures 3 and 4). The riprap revetment slopes down to the beach at approximately 30 degrees. We observed an area approximately 8 feet wide near the base of the exposed revetment where it appeared that armor stone had been plucked from the revetment in the past damaging the revetment (Appendix A).

The site is located on a younger stabilized dune. Elevations on the site range from approximately 26 to 28 feet (NAVD 88) along the western portion of the property to approximately 24 feet (NAVD 88) along the eastern portion of the property. The site slopes gently to the east at approximately 2 to 5 degrees (Figures 3 and 4; Appendix A).

The riprap revetment west of the site generally slopes down to the beach at approximately 30 degrees (Figures 3 and 4; Appendix A).

Lidar data from 2016 shows the junction between the beach and the revetment was at an elevation of approximately 8 feet (NAVD 88) (Figures 3 and 4). Allan and Hart (2005) surveyed the elevation of the beach/dune junction in 1997, 1998, and 2002 at approximately 20 feet, 14 feet, and 16 feet, respectively. Winter elevations primarily depend on beach profiles formed by storm conditions.

The existing revetment located on the western portion of the subject site slopes down to the beach at approximately 30 degrees and consists of angular basalt boulders approximately 4 to 7 feet diameter on its lower portion and approximately 3 to 5 feet diameter on the upper portion (Figure 3; Appendix A). An approximately 8 feet wide area of the revetment appears to have been previously damaged and is missing armor stone near the base (Appendix A). Severe storms in the winter of 2007–2008 partly undermined the revetments in areas located along Neskowin Beach. The riprap revetment greatly reduces the potential for erosion when maintained and repaired as necessary.
